# LANCTW2800 Installation Instructions

Trailer wiring harness kit for 70 & S series combines equipped with Lankota rear combine hitch part number LANTH910 or LANTH400.

# LANKOTA

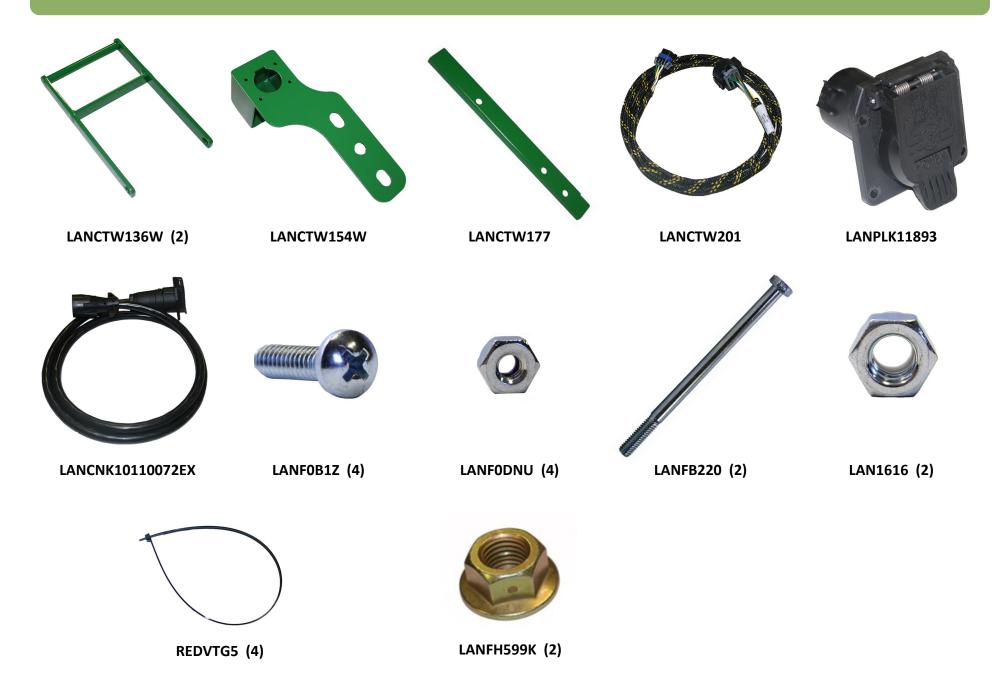
# Pictorial Parts List

Part Numbers	Description	Quantity
LANCTW136W	Hitch Extension Cable Bracket	2
LANCTW154W	Wiring Harness Bracket Weldment	1
LANCTW177	Wiring Harness Shield (70 & S Series)	1
LANCTW201	Wiring Harness for 70 & S Series Combines	1
LANPLK11893	7-way socket body	1
LANCNK10110072EX	6 foot 7-Way extension cable	1
LANF0B1Z	10-24 X 3/4" Pan Head Phillips Machine Screw, Zinc	4
LANFODNU	10-24 Nylon Insert Lock Nut, Zinc	4
LANFB220	5/16" - 18 X 5" G5 Hex Head Cap Screw, Zinc	2
LAN1616	5/16" - 18 Nylon Lock Nut	2
LANFH599K	M20 Flange Head Center Lock Nut	2
REDVTG5	24" cable tie	4

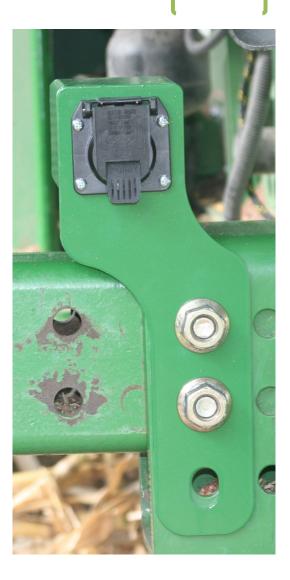
Figure 1.1

1. Install 7-way Socket Body (LANPLK11893) into Wiring Harness Bracket Weldment (LANCTW154W) using four Machine Screws (LANF0B1Z) and Nylon Lock Nuts (LANF0DNU). Tighten all hardware.

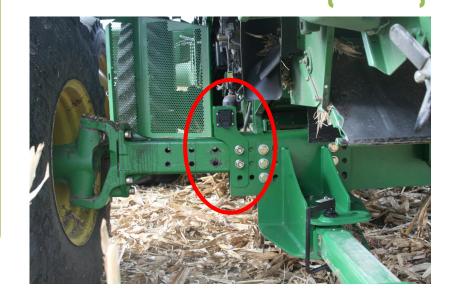
2. Remove the two outside most axel bolts on the left side of rear axle. Retain hardware for re-installation later in these instructions.

3. Install Wiring Harness Bracket Weldment (LANCTW154W), with 7-way Socket Body (LANPLK11893) already installed, using the two bolts and nuts removed in step 1 of these instructions. Tighten all hardware.

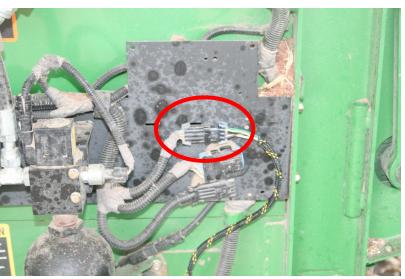
Figure 1.7

- 4. On left side of combine, open metal meshed shield in front of battery box exposing wiring harnesses as shown in Figure 1.5.
- 5. Remove dust cover from harness circled by the RED CIRCLE in Figure 1.7. Attach Wiring Harness (LANCTW201) to factory connector.

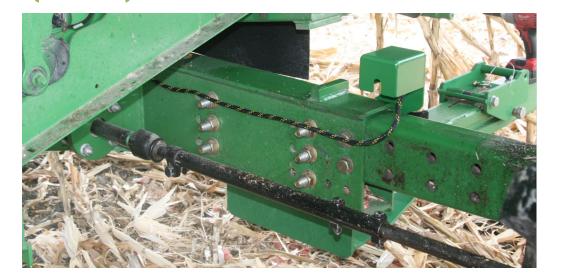
Figure 1.8

- 6. Route wiring harness as shown.
- 7. Connect harness to rear of 7-way Socket Body (LANPLK11893) installed into Wiring Harness Bracket Weldment (LANCTW154W).

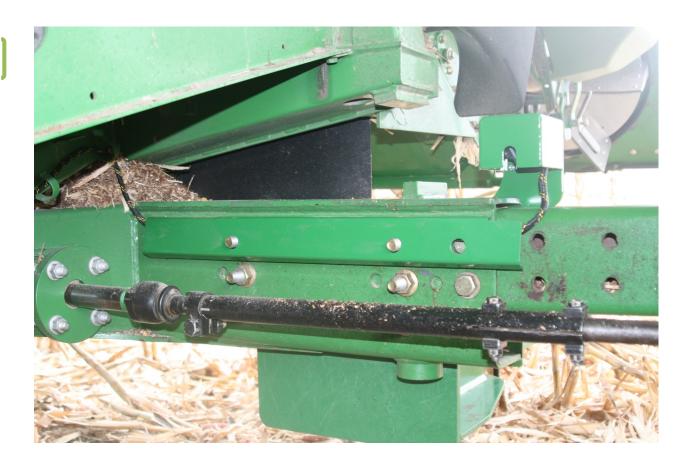
Figure 1.10

8. Install Wiring Harness Shield (LANCTW177) using two M20 Flange Head Center Lock Nuts (LANFH599K). Tighten all hardware.

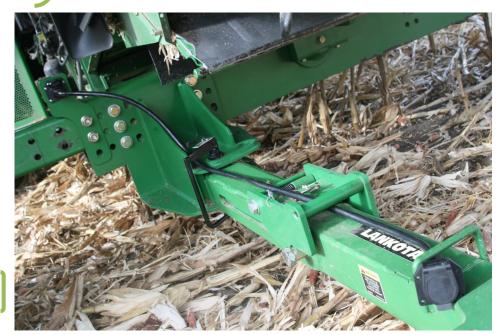
#### **Refer To Figure 1.11**

- 9. Route 6 foot 7 way extension cable (LANCNK10110072EX) through Rear Combine Hitch (LANTH910) pivot pin locking arm, telescoping locking handle and stationary pull handle as shown.
- 10. Connect 6 foot 7 way extension cable (LANCNK10110072EX) to 7-way Socket Body (LANPLK11893) installed into Wiring Harness Bracket Weldment (LANCTW154W).

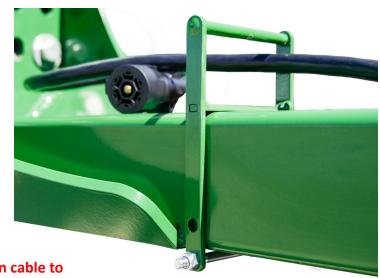
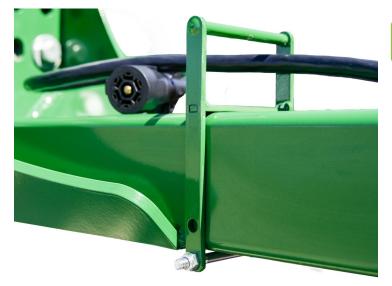
Figure 1.12

- 1. Install two Hitch Extension Cable Brackets (LANCTW136W) to the LANTH400 hitch as shown using one 5/16" 18 X 5" G5 Hex Head Cap Screw (LANFB220) and one 5/16" 18 Nylon Lock Nut (LAN1616) per bracket. Tighten all hardware.
- 2. Route 6 foot 7 way extension cable (LANCNK10110072EX) through Rear Combine Hitch (LANTH400) as shown.

Four 24" Cable Ties (REDVTG5) are supplied in this kit if you prefer to secure extension cable to hitch. However it is recommended to unhook extension from combine mounted socket whenever unhooking header trailer and leave extension with trailer. This will eliminate the possibility of the wiring extension being damaged from straw chopper debris.
